# REVIVAL OF THE FITTEST—PART VI

## Project '67 Camaro Z/28

### Body Beautiful — And A Little Color

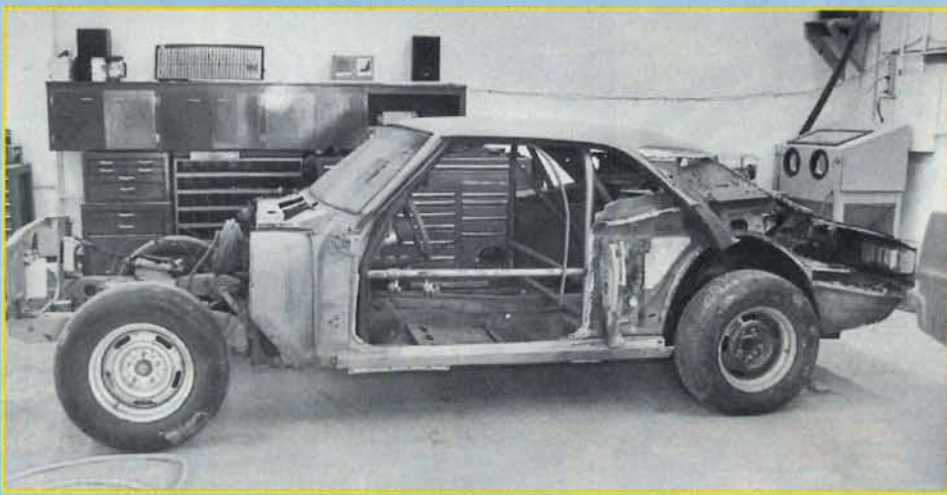
*There's no better way to elicit a true sense of satisfaction when restoring a car than to see it emerge from the spray booth with a new coat of paint — or in the case of our '67 Trans Am Z/28 — paint and stripes. However, it doesn't hurt to know that all of the underlying sheetmetal is in great shape, either, so that's why we spared no expense in making sure the body panels were either new or as straight as possible. The car received new quarters, driver's side door skin, fenders, header panel, lower valance and trunk lid.*

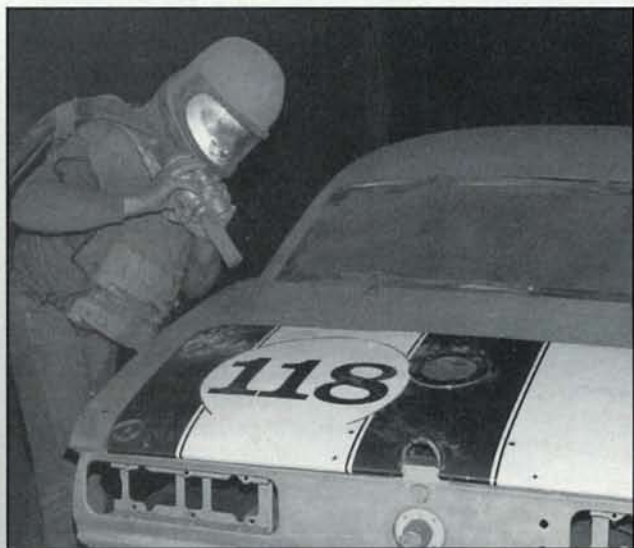
As we've found out in past (and current) projects, the best way to apply a new outer look is when all of the underlying coats of paint have been stripped off. So far, we've investigated acid-stripping, soda-blasting and most recently walnut blasting and all have done a fine job at getting it done. For the Z/28, however, we decided to have Fred Macary at BlasTech in Tumwater, Washington, remove the 25 years of paint with a special process that uses walnut shells mixed with a very fine mesh garnet. This procedure, Fred feels, is the most effective way of removing paint, rust and body fillers without causing pitting of the sheetmetal. After taking a look at the final results, we can verify that the surface is free of paint and there is no surface degradation.

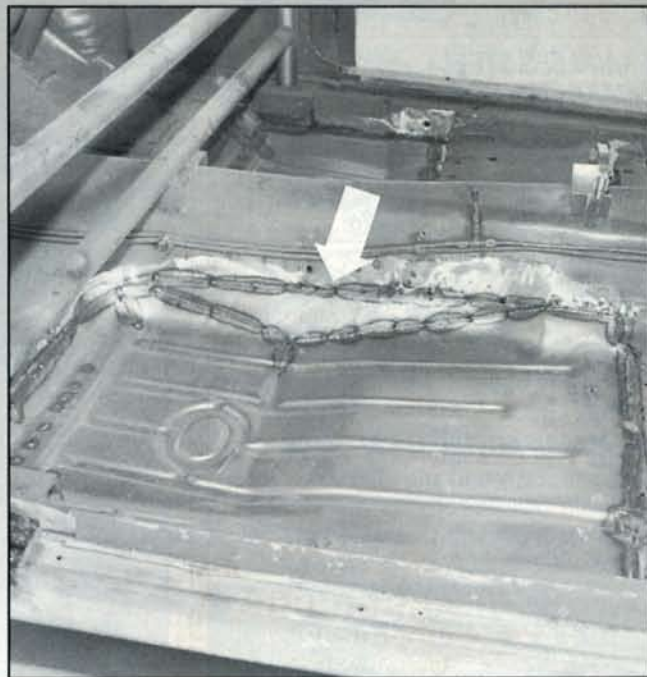
*After years of racing under all kinds of conditions, it was necessary to have a full pan spliced in behind the passenger's seat and about three-quarters of one on the driver's side. Sheetmetal wizard Brandon Huhtala, who specializes in restoring Camaros, had to fabricate an extra piece (arrow) for the passenger side since the reproduction panel didn't exactly fit.*

One area that required some serious surgery was the floor pans. After many years of competing on various racing surfaces, the floorboards right behind the seats — on both sides of the car — were in dire need of being replaced. The passenger side was the worst, necessitating a full pan (and an extra fabricated piece to go up the side of the hump) behind the seat mounts, while the driver's side only required roughly two-thirds of the area to be replaced.

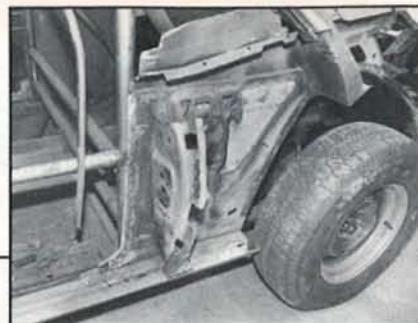
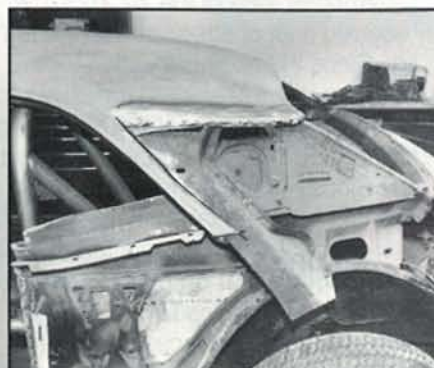
One of the most delicate surgical operations on the Z/28 involved removing and replacing the rear quarter panels. When Brandon received the Camaro, he had to redo the work that had been started by a previous body shop. This required complete removal of the whole quarter panel and outer wheel housing on each side. A steady hand and the correct tools were needed to make the necessary cuts to separate the old quarters from the inner structure.

Brandon cut a hole around each factory

spot weld then rewelded the NOS quarters in place. At the roofline, Brandon used a low-heat torch to melt away the old lead filler, then used plastic body putty to seam up the new quarter to the existing roof.

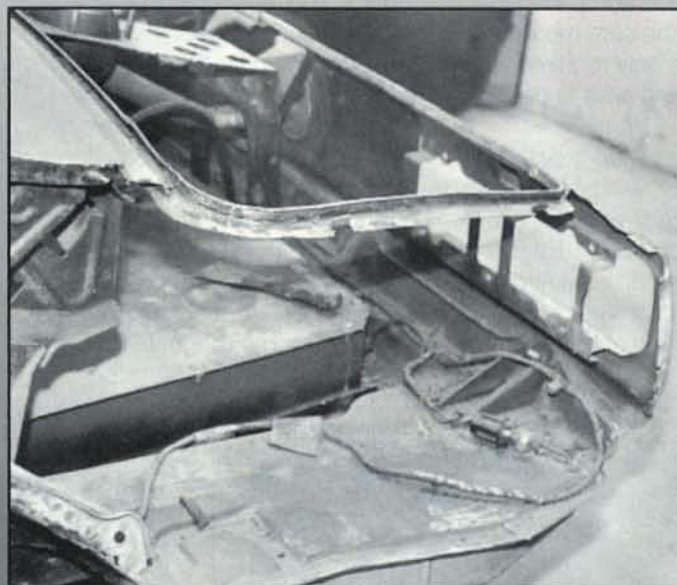
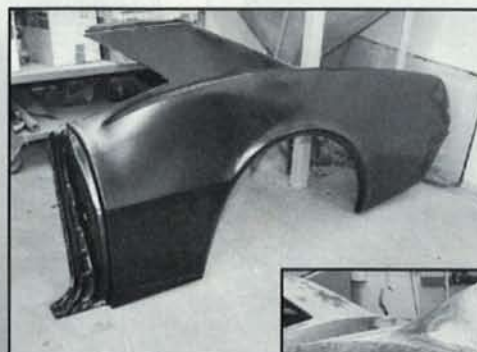
Hanging the genuine GM NOS quarter panels and outer wheel housings from Steve's Camaros still required a lot of work to properly align and weld in place. More than 30 hours were spent making sure everything was perfect, including the original-type factory spot welds that Brandon meticulously duplicated.

After the old quarters were removed, Brandon went about fitting the new old stock units in place and even went so far as to duplicate the original spot welds rather than laying down an unsightly bead. Contrary to what many people think, even original factory sheetmetal still needs a lot of work to make perfect; Brandon had at least 30 hours in the rear quarters of the car.

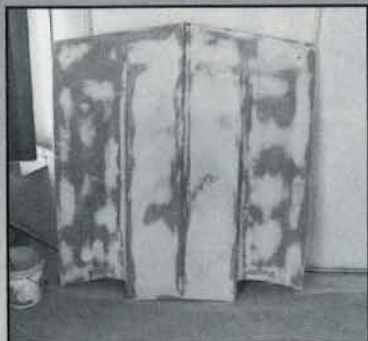
The cowl-induction hood of our Z/28 is a rare original fiberglass unit that was available over the counter in 1969 and was designed to fit the factory cross-ram induction system. It required a good deal of labor to get into shape, but fortunately, there were no major areas that needed to be repaired.

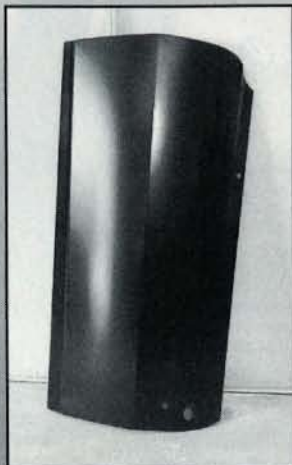
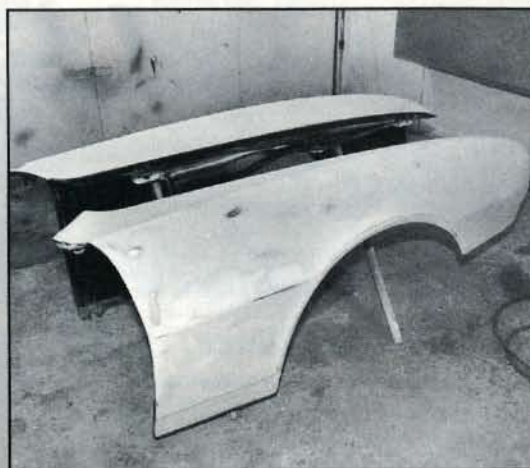
After the old skin was removed and an NOS one was installed on the dented-up driver's door, it, along with the reproduction front fenders, original windshield wiper cowl and new header panel and valance, were block sanded, primed and block sanded again until everything was as straight as possible. When it came time to apply the color, Brandon painted every part independently and then attached it to the body.

ment part. "It was also necessary to reskin the driver's door," explained Brandon, "because it had taken quite a few hits over the years and there were a couple of dents in it. It was pretty easy, but (the new skin) did require some block sanding and prep to get it straight."

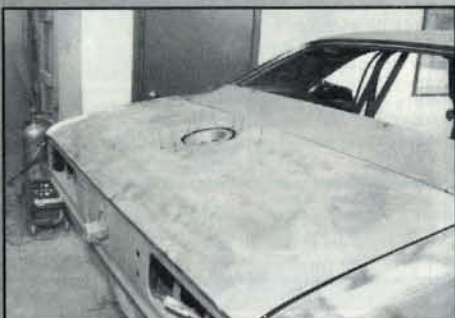
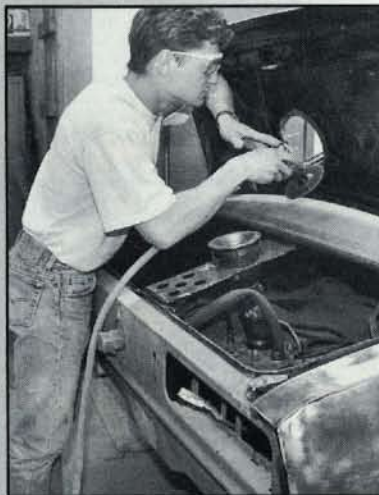
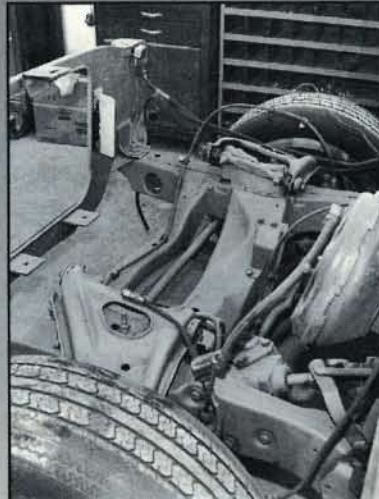
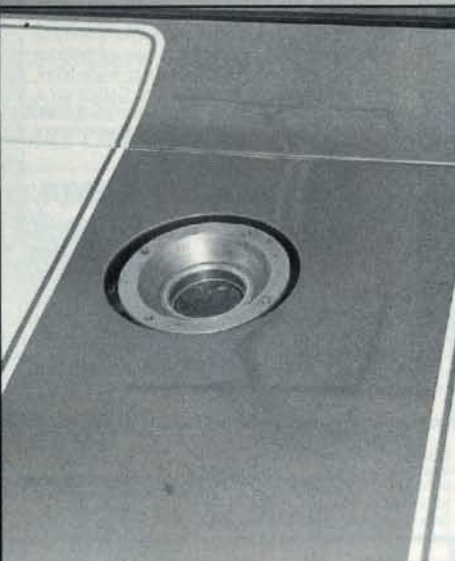
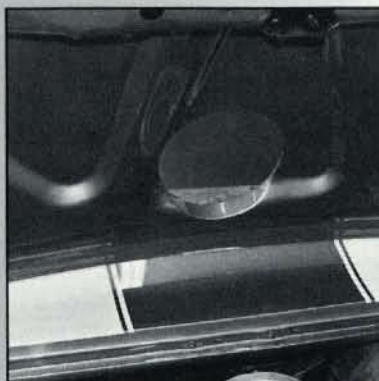
Because the factory Trans Am fuel cell was mounted in the trunk and required an opening in the lid to accommodate the filler spout, Brandon had to cut a large hole in the new trunk lid. This required a lot of massaging to get it perfect, but when it was done, it looked as though the factory had built it that way. Check out the finished radius between the inside and outside layers of the sheetmetal. Here, Brandon welded the two together and smoothed it out. We'd say it looks great!

Another area of the '67 Z/28 that received a lot of attention was the trunk lid. Since the original location for the fuel tank in the Trans Am racer was in the trunk, it was natural for the filler neck to protrude through a gaping hole in the lid. Since our project received a new Jaz fuel cell to replace the original in the trunk and a new lid without the requisite hole, it meant that Brandon needed to cut one out. The result was nothing less than a stellar piece of art. What Brandon had to do was mate both the inner and outer pieces of sheetmetal and weld them together to maintain structural integrity, then produce a nice contour integrated between them.

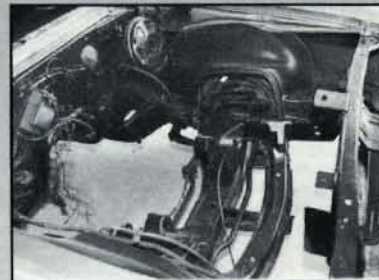
Since the subframe went through the walnut blasting process and had many years of old paint removed, it only made sense for it to receive a fresh coat of PPG DP-90 semi-gloss black paint. There's no denying how clean an engine compartment looks when it's painted nicely.

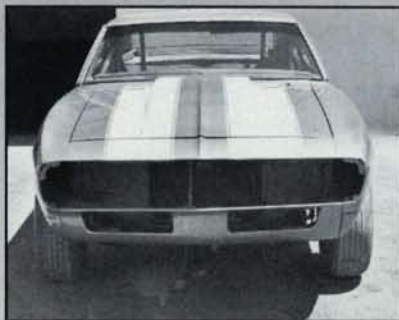
Since Brandon likes to spray all of the body parts individually rather than on the car, it makes for an even paint job where the door jambs and trunk and hood sealing areas all look as good as the outer coats of paint. This way, there's no tape marks or overspray and all areas get painted. After all of the painted sheetmetal was hung, Brandon applied the original white stripes over the blue coat.

Stripes, perfectly-aligned body panels and a bright blue coat of PPG paint. Our Trans Am Camaro is really shaping up. It even received a new windshield and backlight glass while at Brandon's shop. It won't be long now before the finished car will be whizzing around the track on the nostalgia racing circuit.
